Situation Photo Log

Friday, March 16, 2012

Kalamazoo River / Enbridge Spill

Larry Rader
START-USEPA
Situation Unit Leader

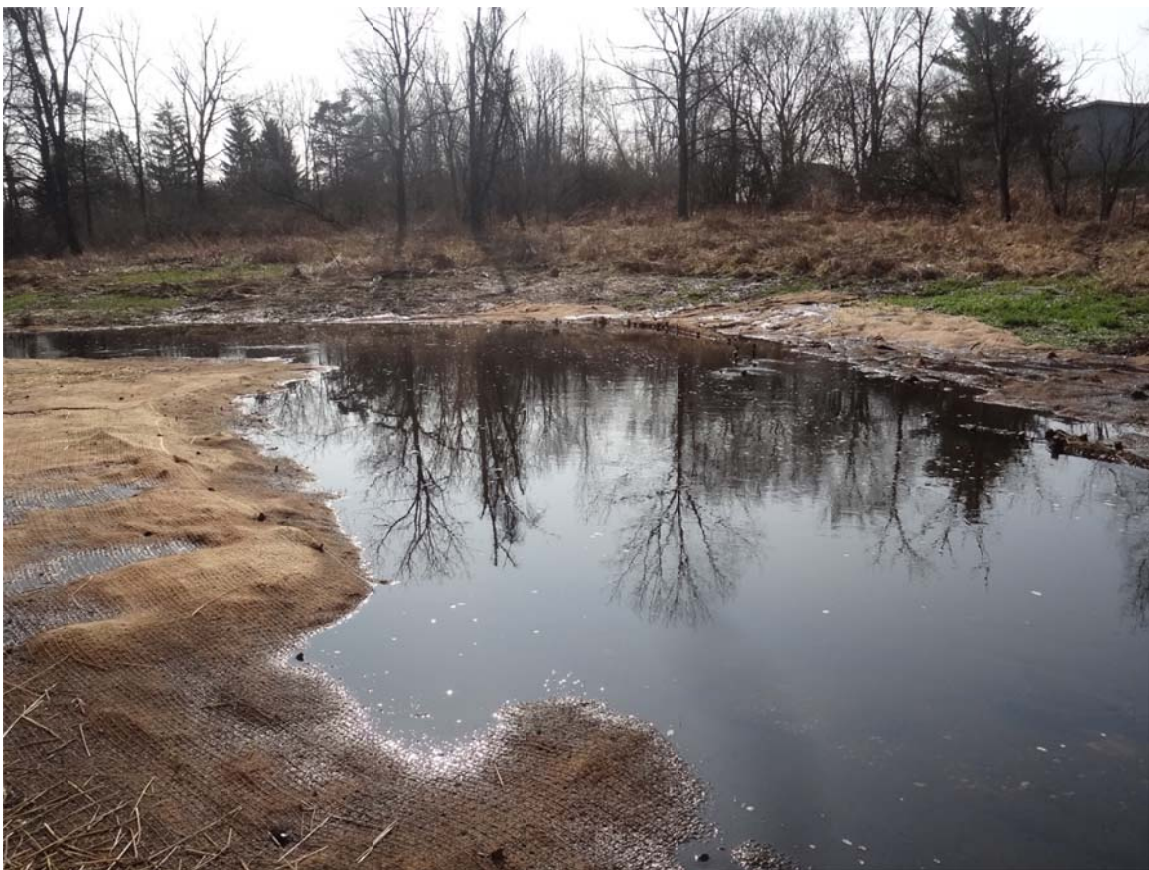
1. Talmadge Creek east of 15-1/2 Mile Road. Water levels are up due to heavy rains overnight.

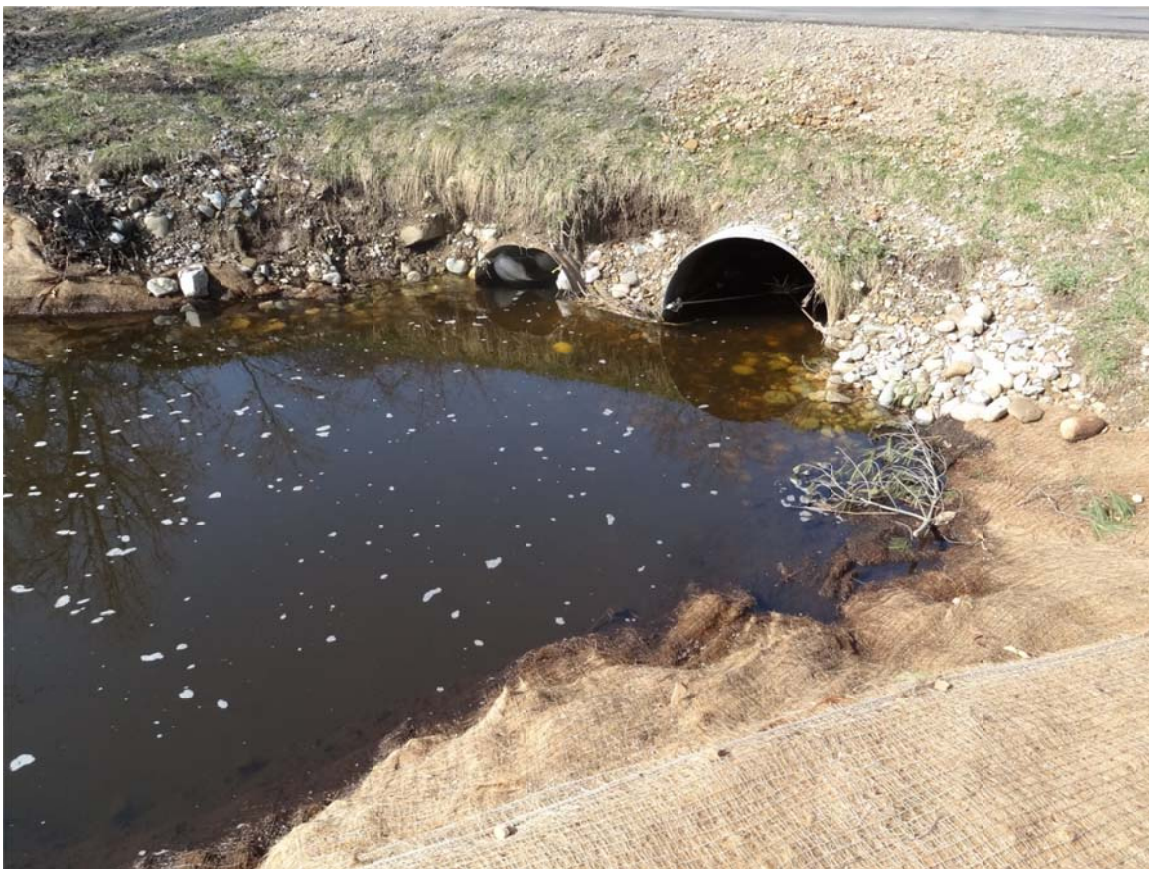
2. Talmadge Creek, culvert east of 15-1/2 Mile Road. Water levels and turbidity have increased overnight.

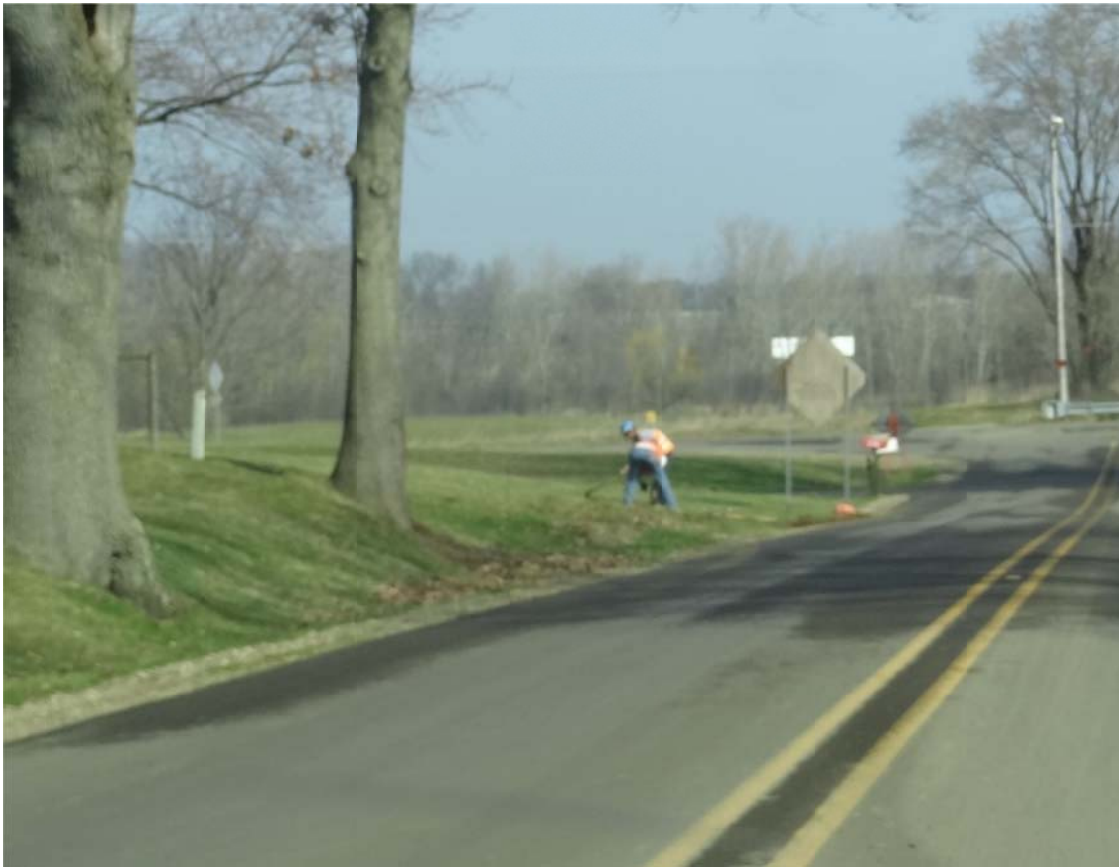
3. Crews continue roadside cleanup along 15-1/2 Mile Road.

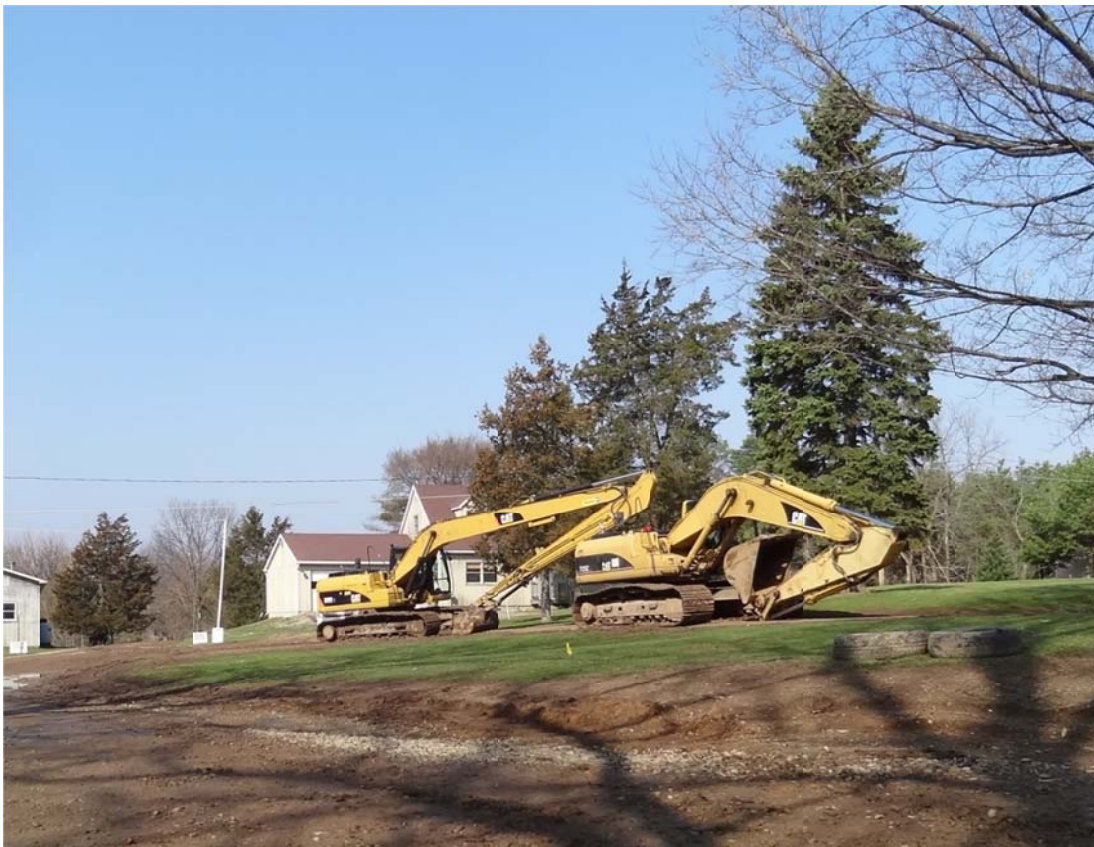
4. Excavators parked for demobilization at house on 15-1/2 Mile Road.

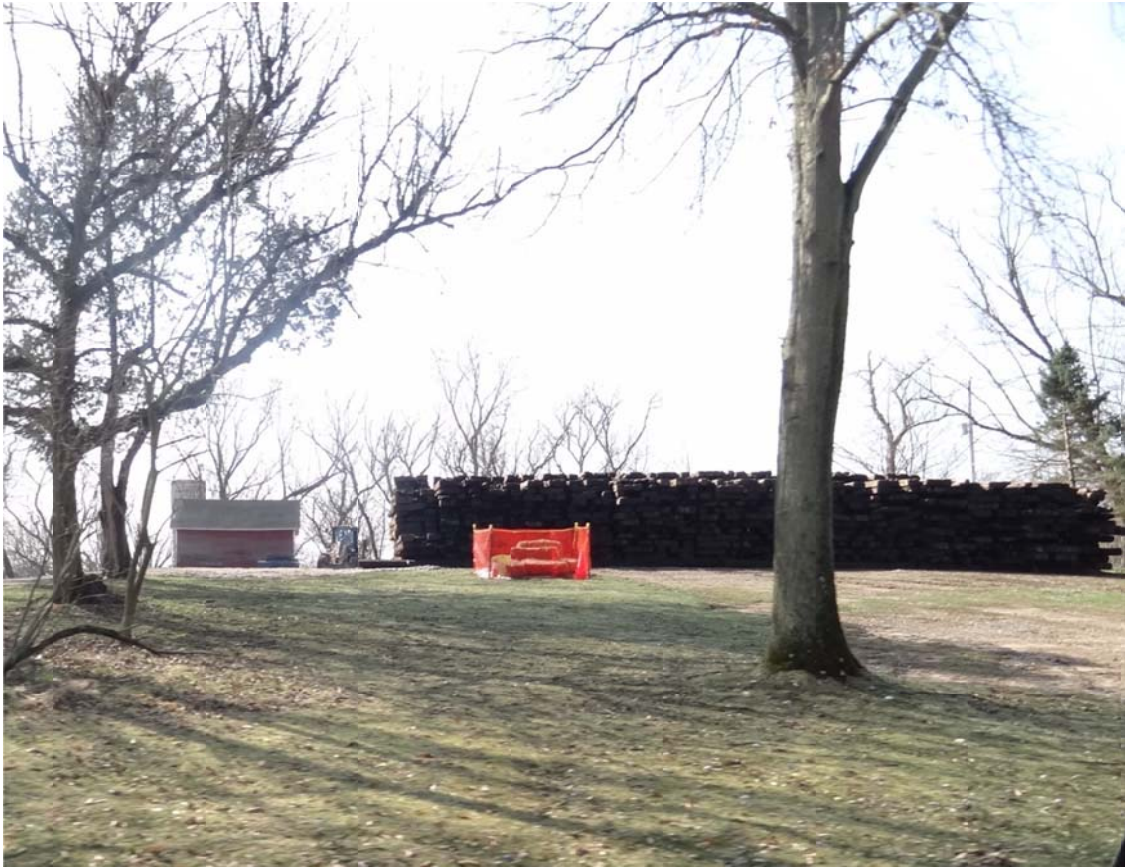
5. Timber mats staged for removal at farmhouse on Division Drive.

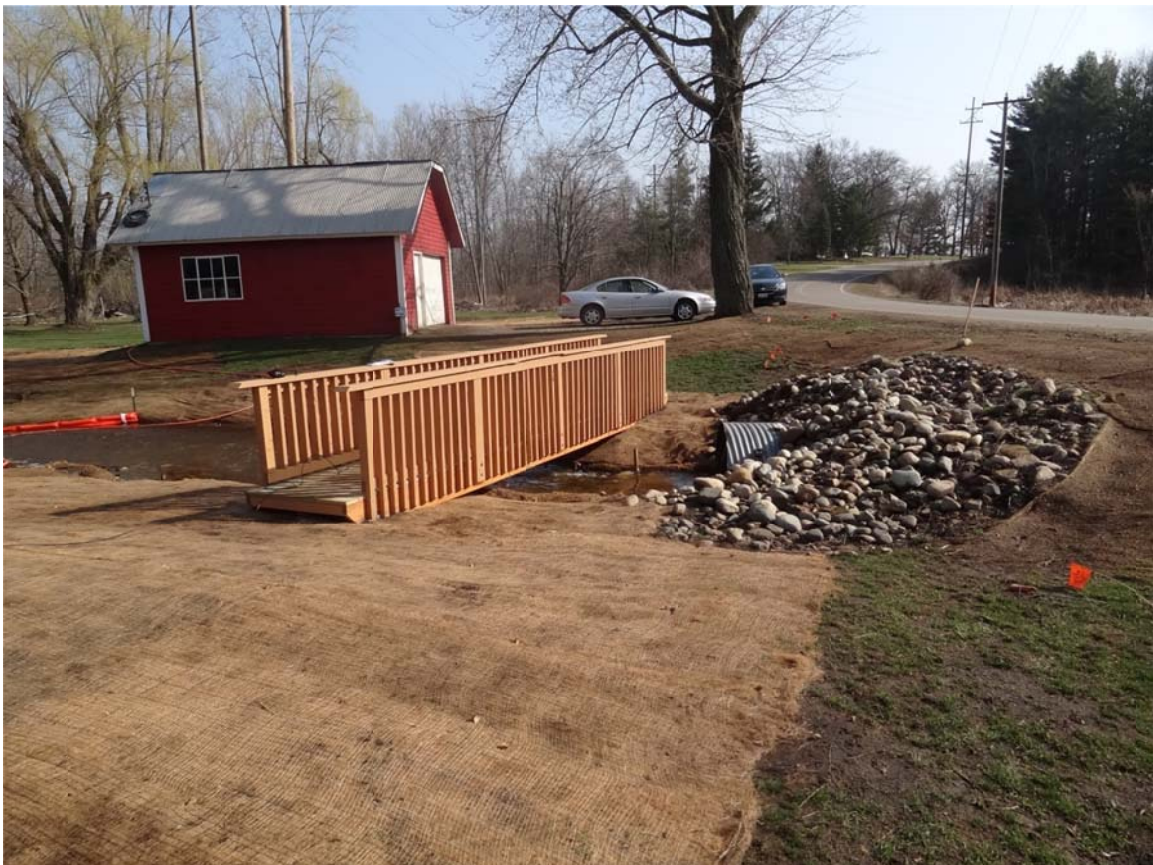
6. Newly constructed bridge on north side of A Drive at Confluence.

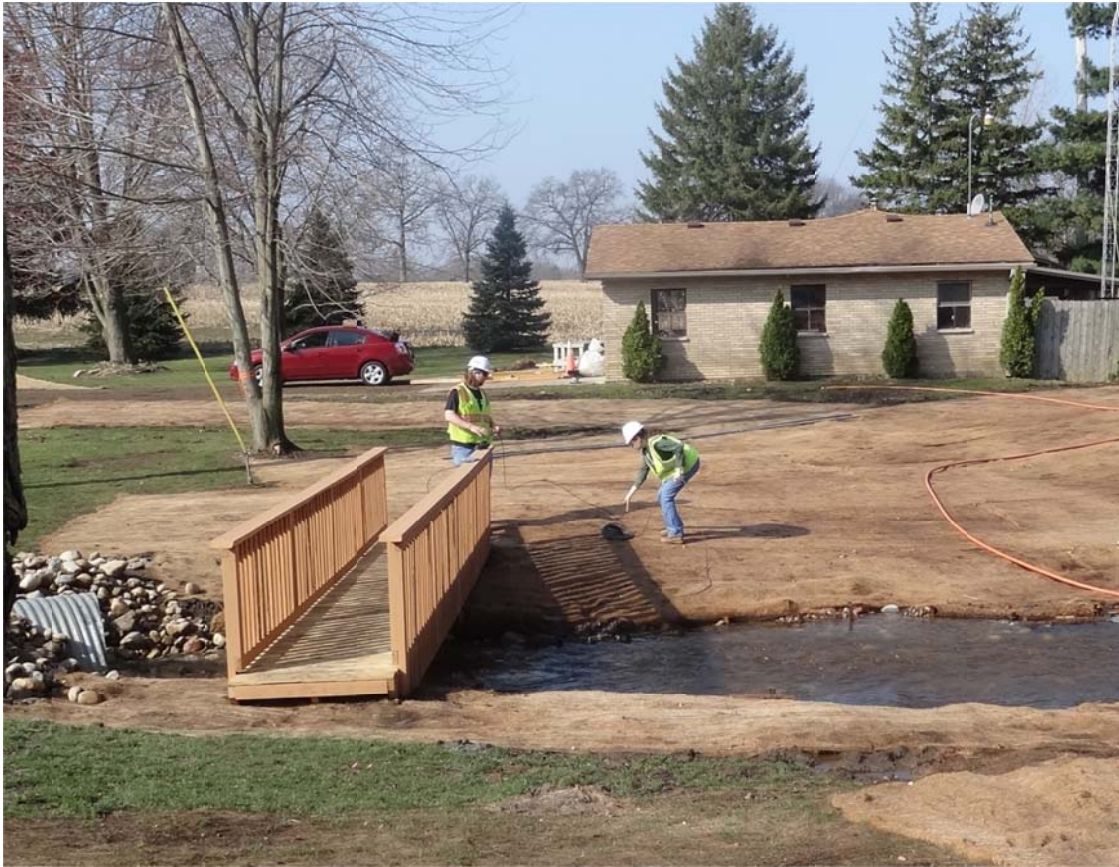
7. Talmadge Creek: crews installing water quality monitor at Confluence.

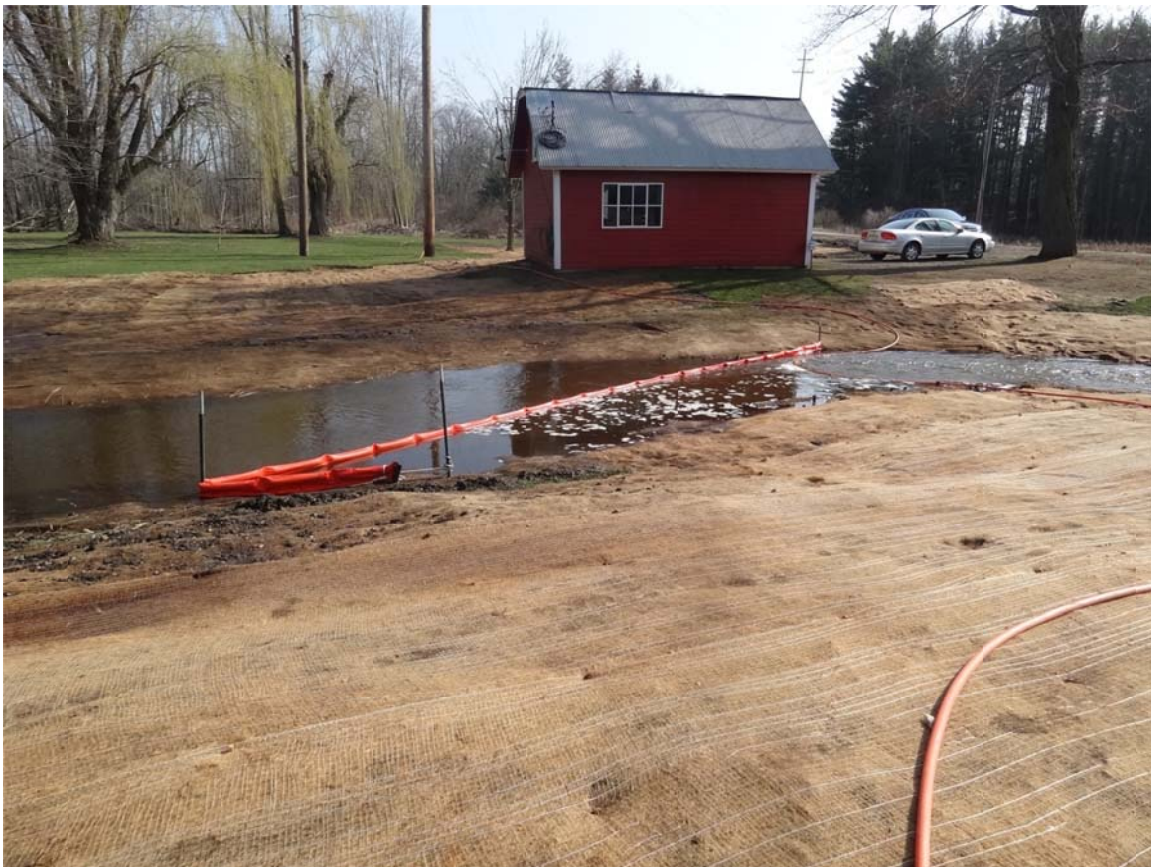
8. Confluence, newly installed containment boom on north side of A Drive.

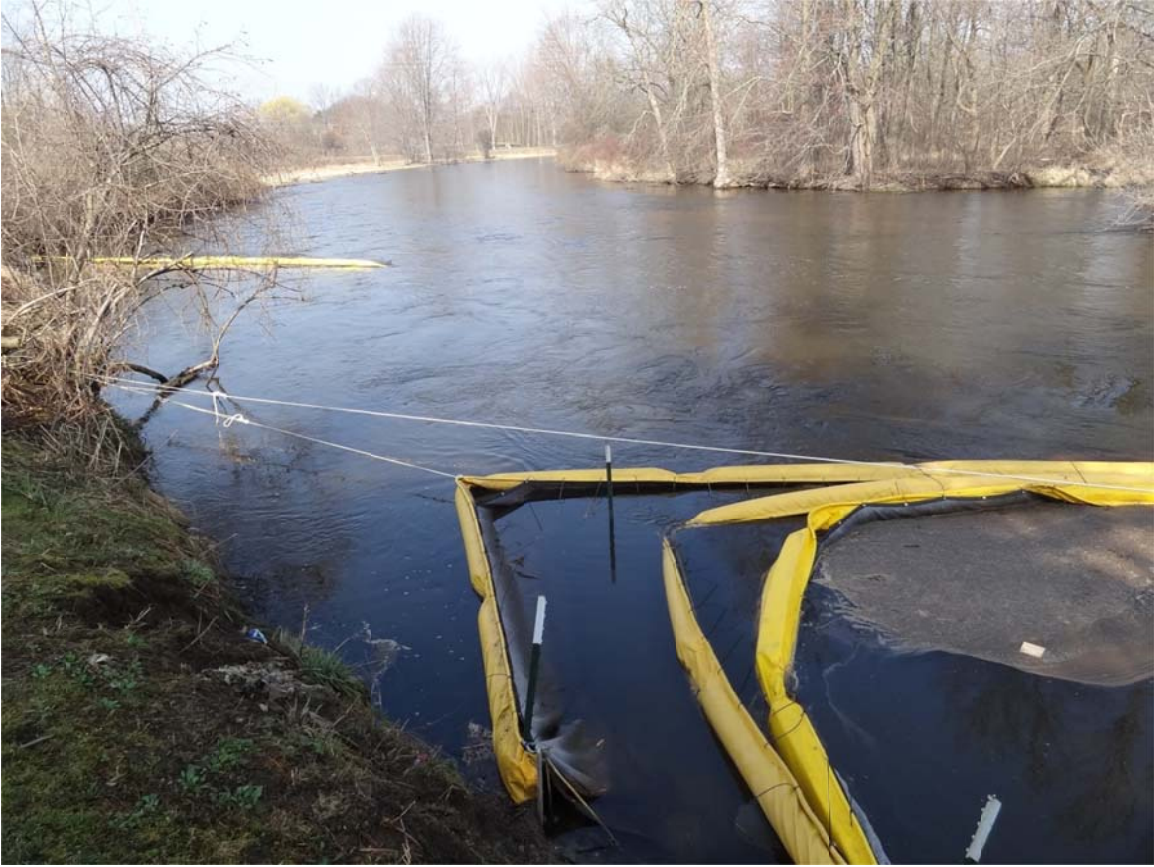
9. Confluence containment boom. No sheen observed.

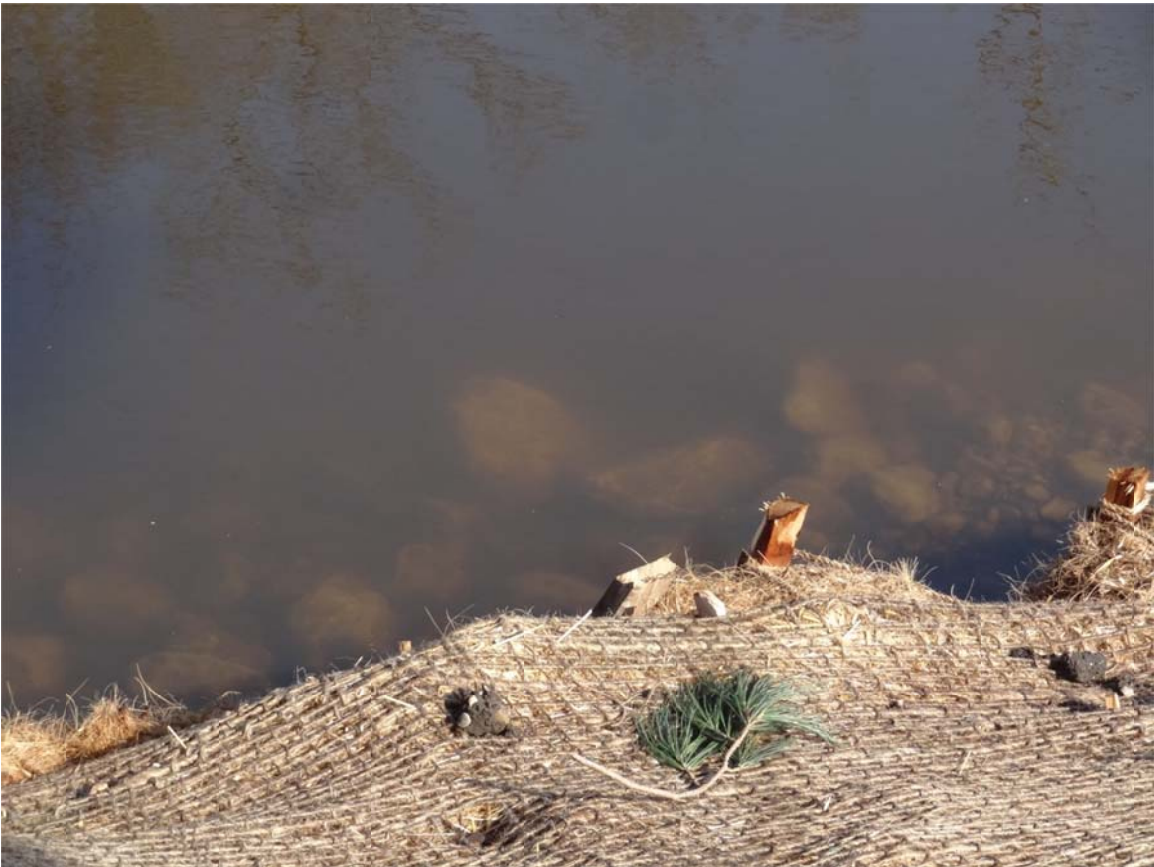
10. Confluence, elevated turbidity along river shoreline.

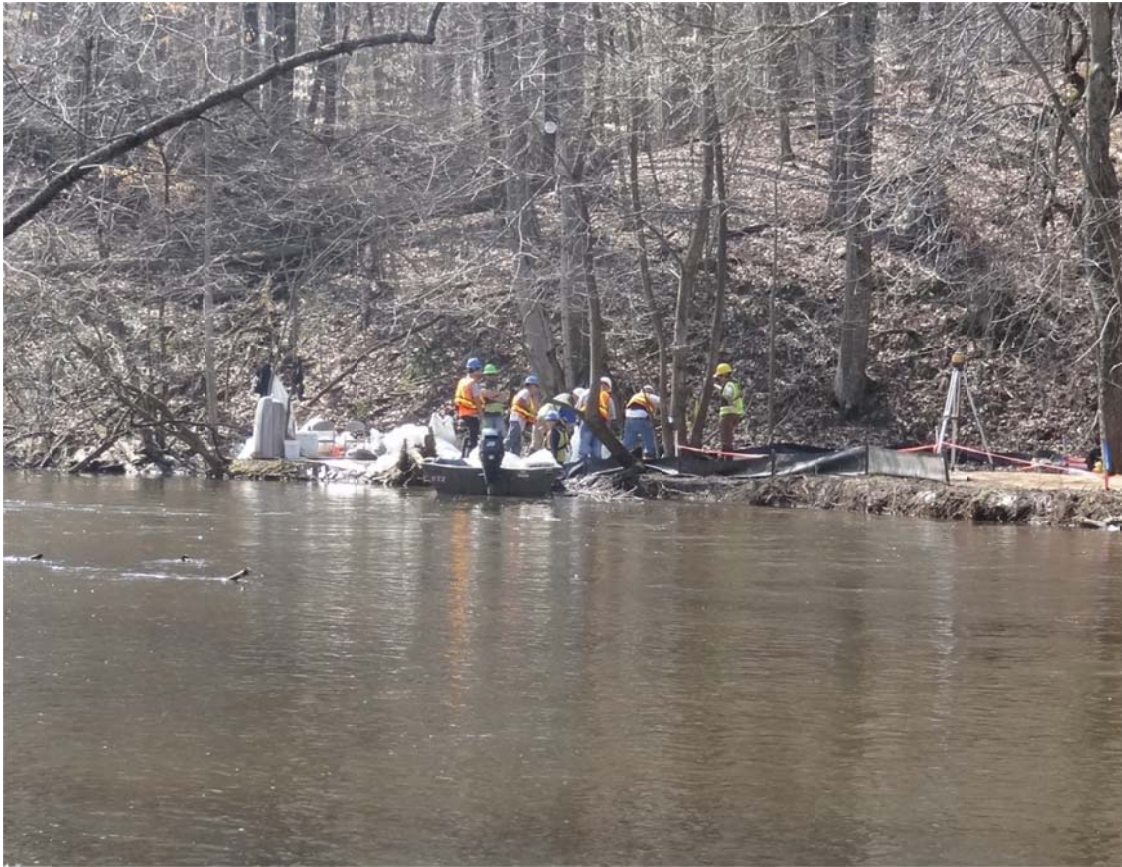
11. OB 9.10 LDB, soil scrape continues.

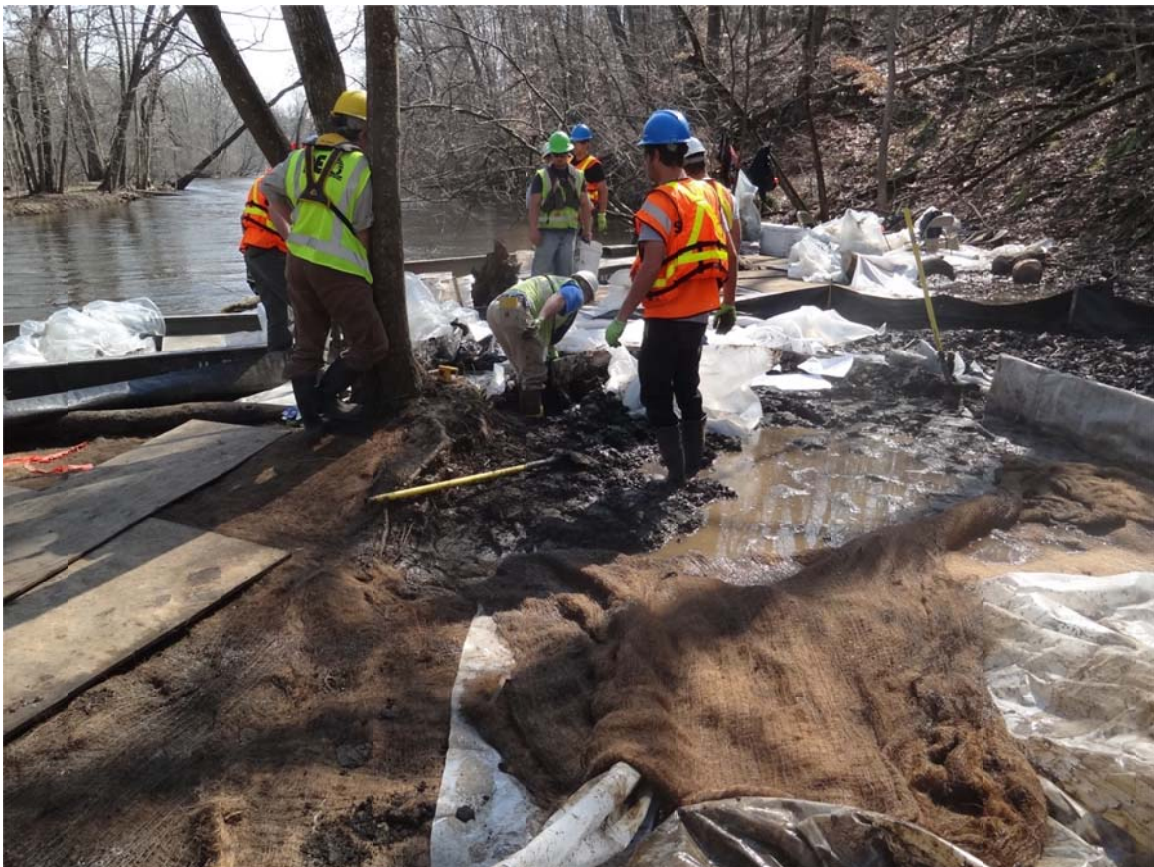
12. OB 9.10 LDB, crews finishing up soil scrape activities.

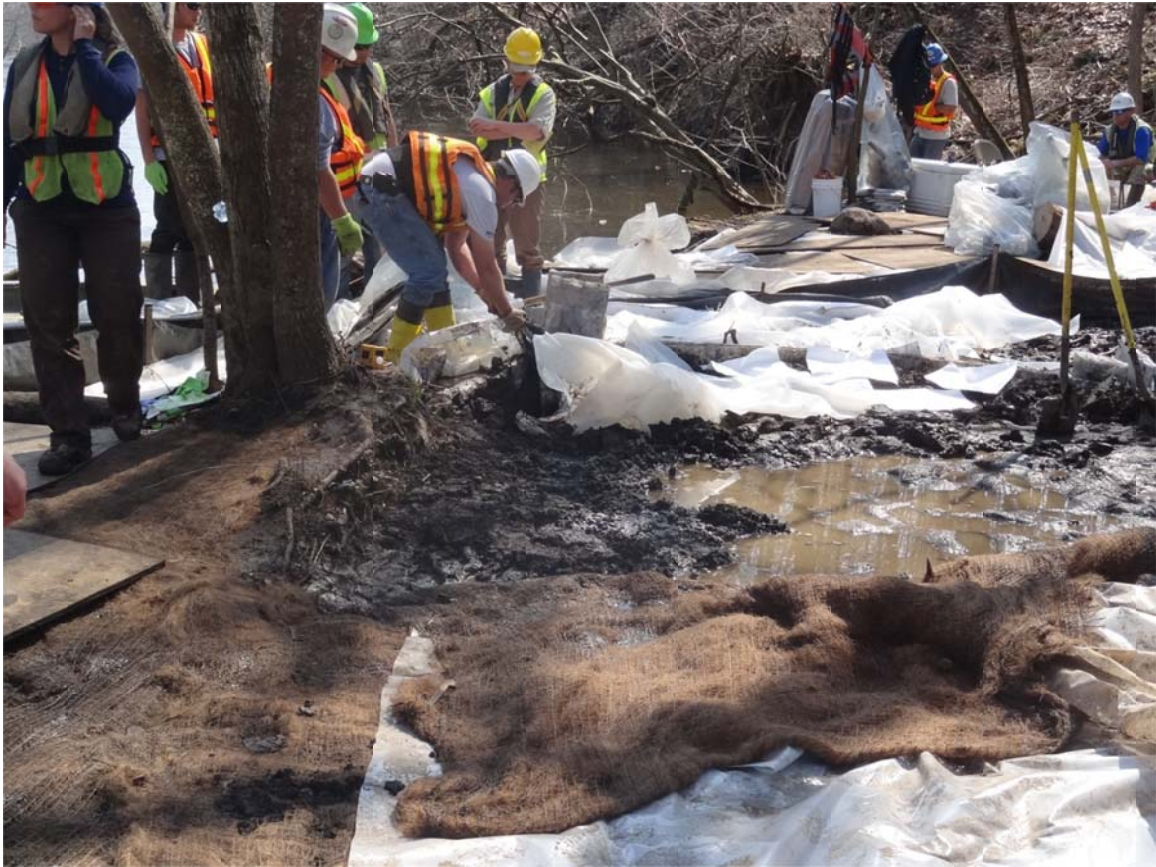
13. OB 9.10 LDB, crews removing plastic to finish scrape activities.

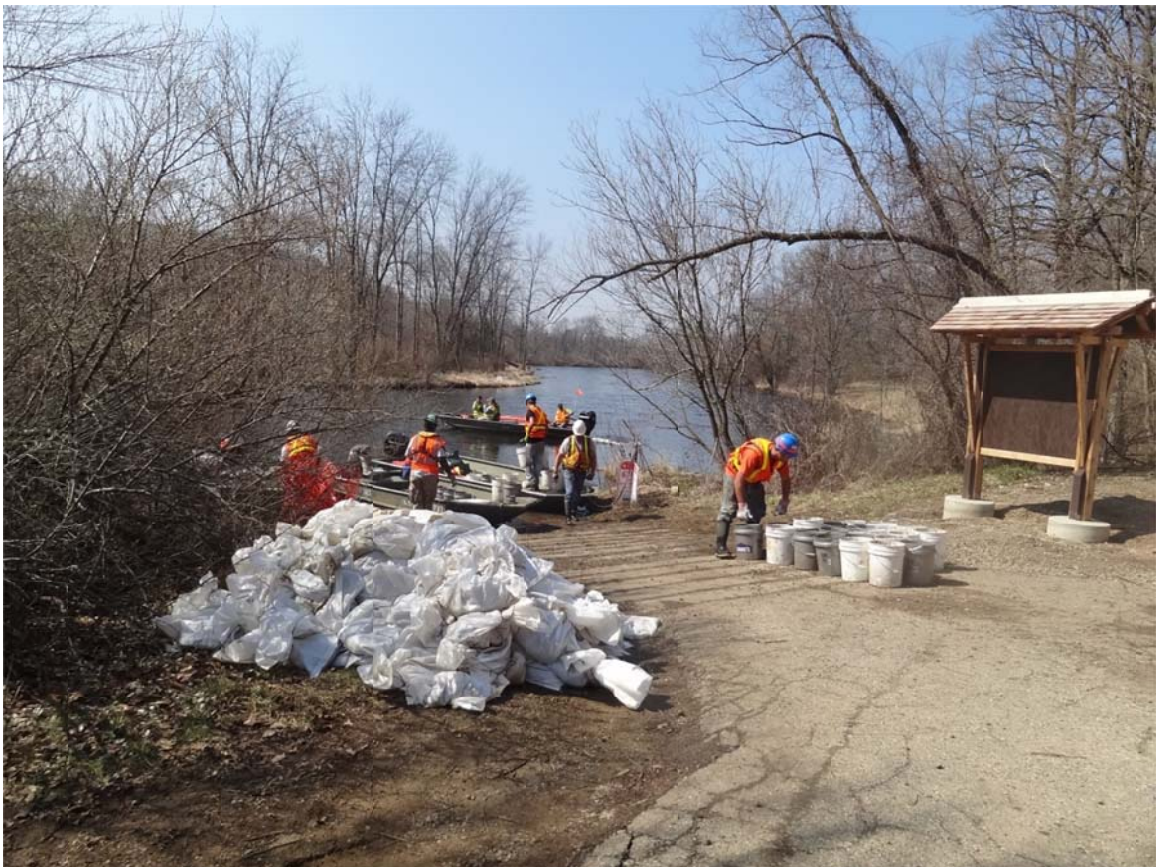
14. Historic Bridge Park boat launch, crews loading boats with clean soil to backfill scraped area at OB 9.10 LDB.

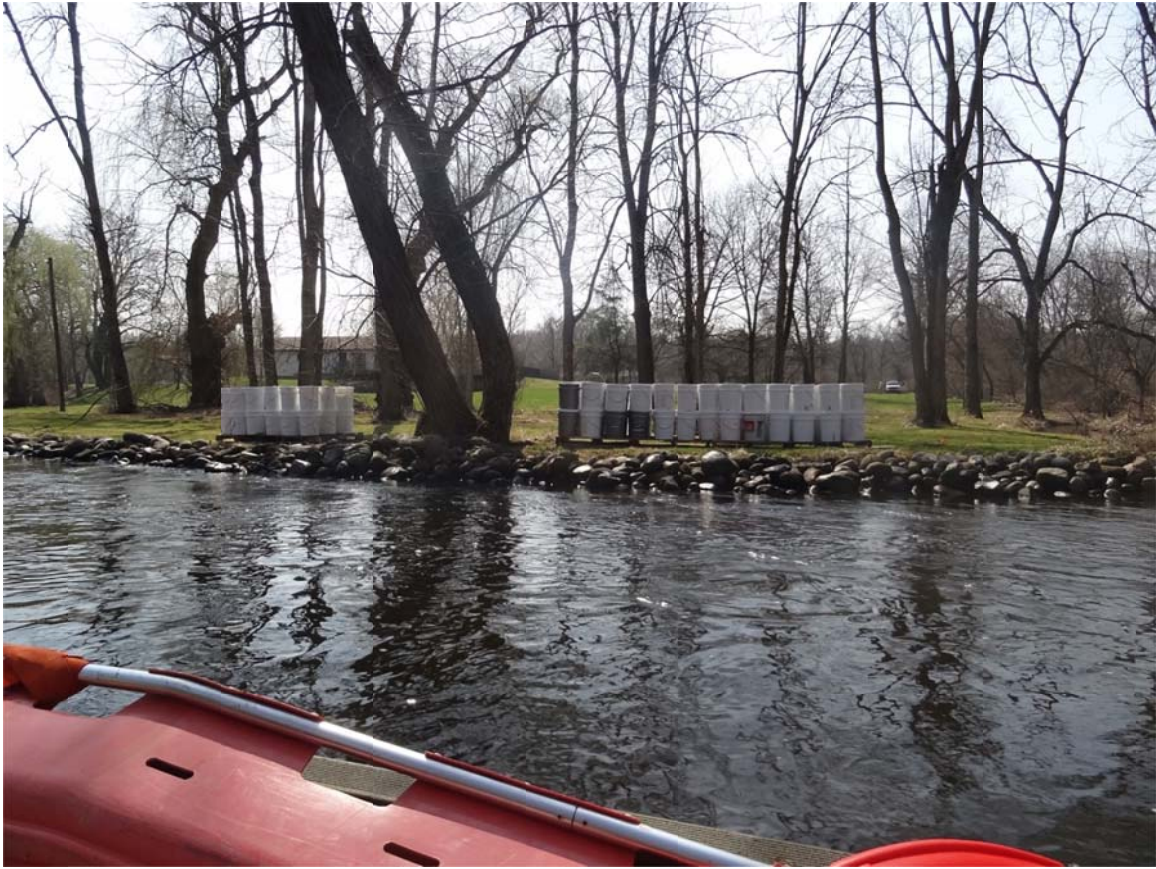
15. Material staged along LDB for planned scrape at OB 10.37 RDB.

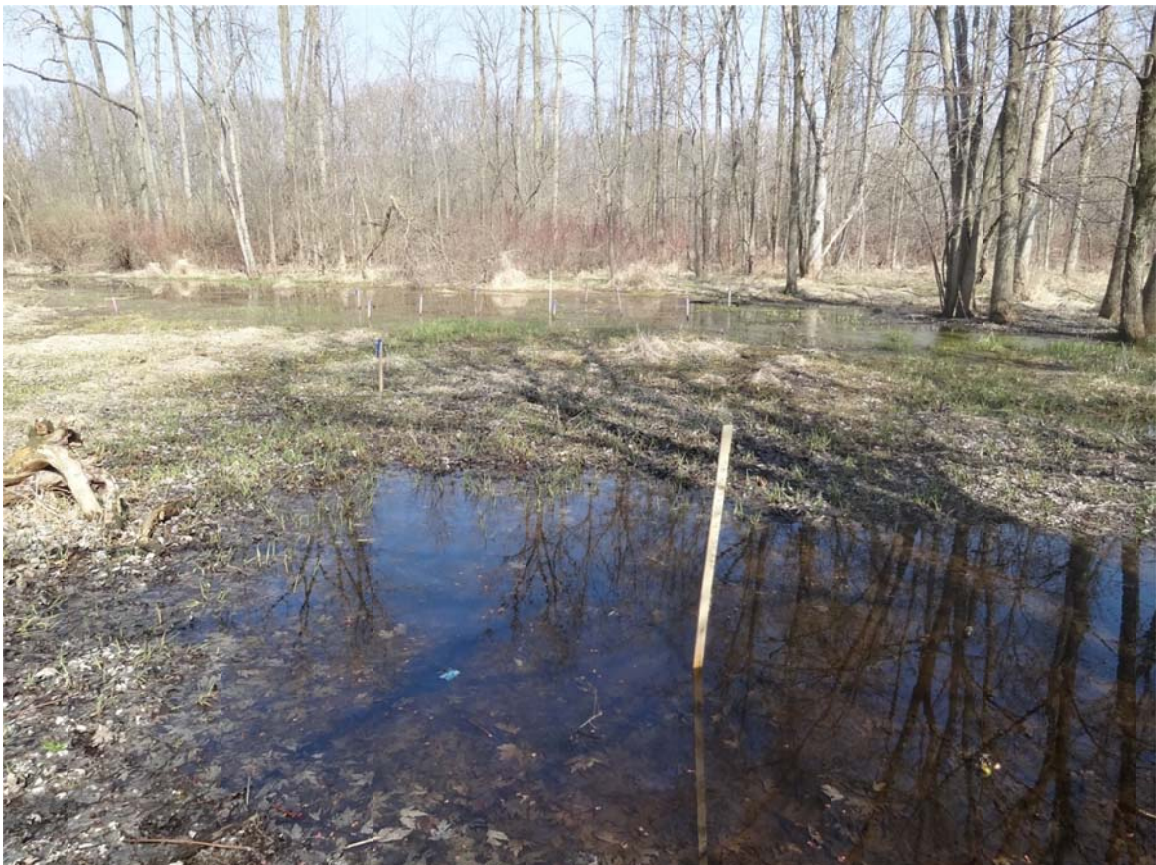
16. Location of planned scrape at OB 10.37 RDB. Some standing water remains.

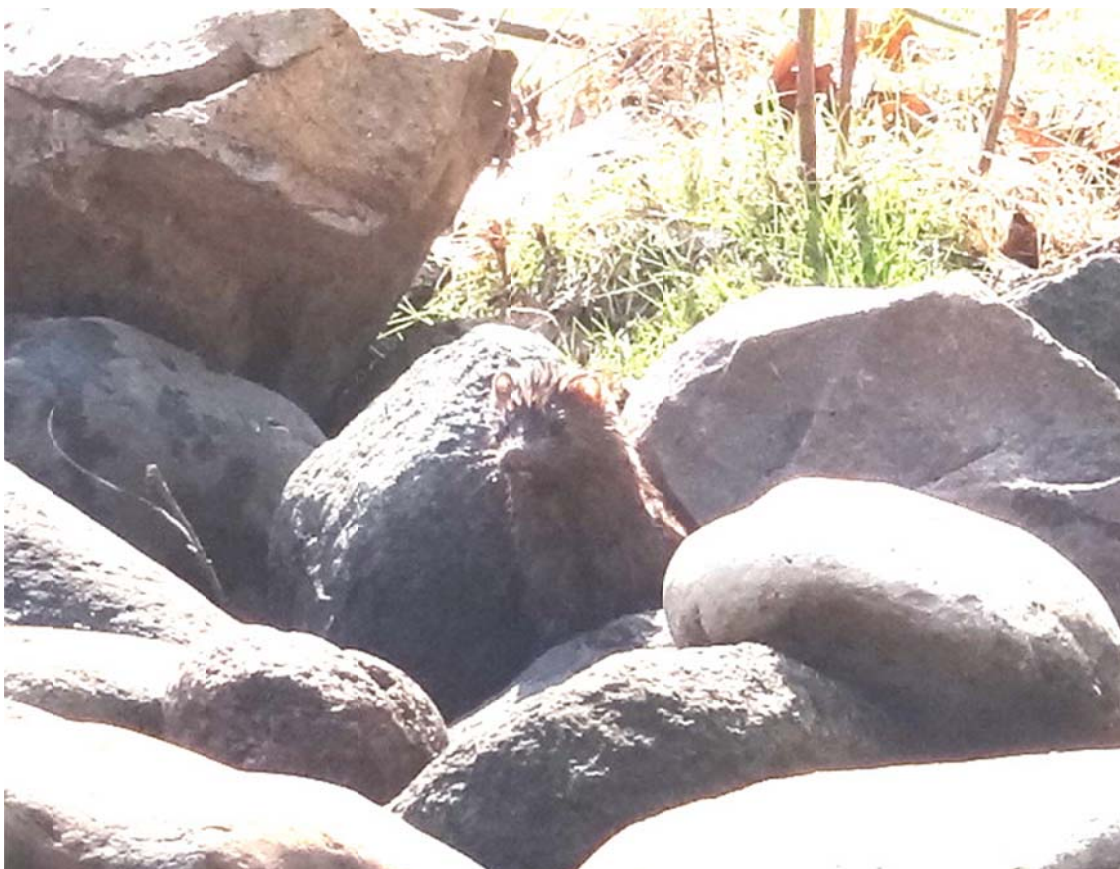
17. Mink observed along LDB near MP 10.75.
